THE MALDEN SURVEY

A REPORT ON THE CHURCH PLANTS OF
A TYPICAL CITY, SHOWING THE USE
OF THE INTERCHURCH WORLD MOVE-
MENT SCORE CARD AND STANDARDS
FOR RATING CITY CHURCH PLANTS

Compiled Under the Direction of
WALTER SCOTT ATHEARN

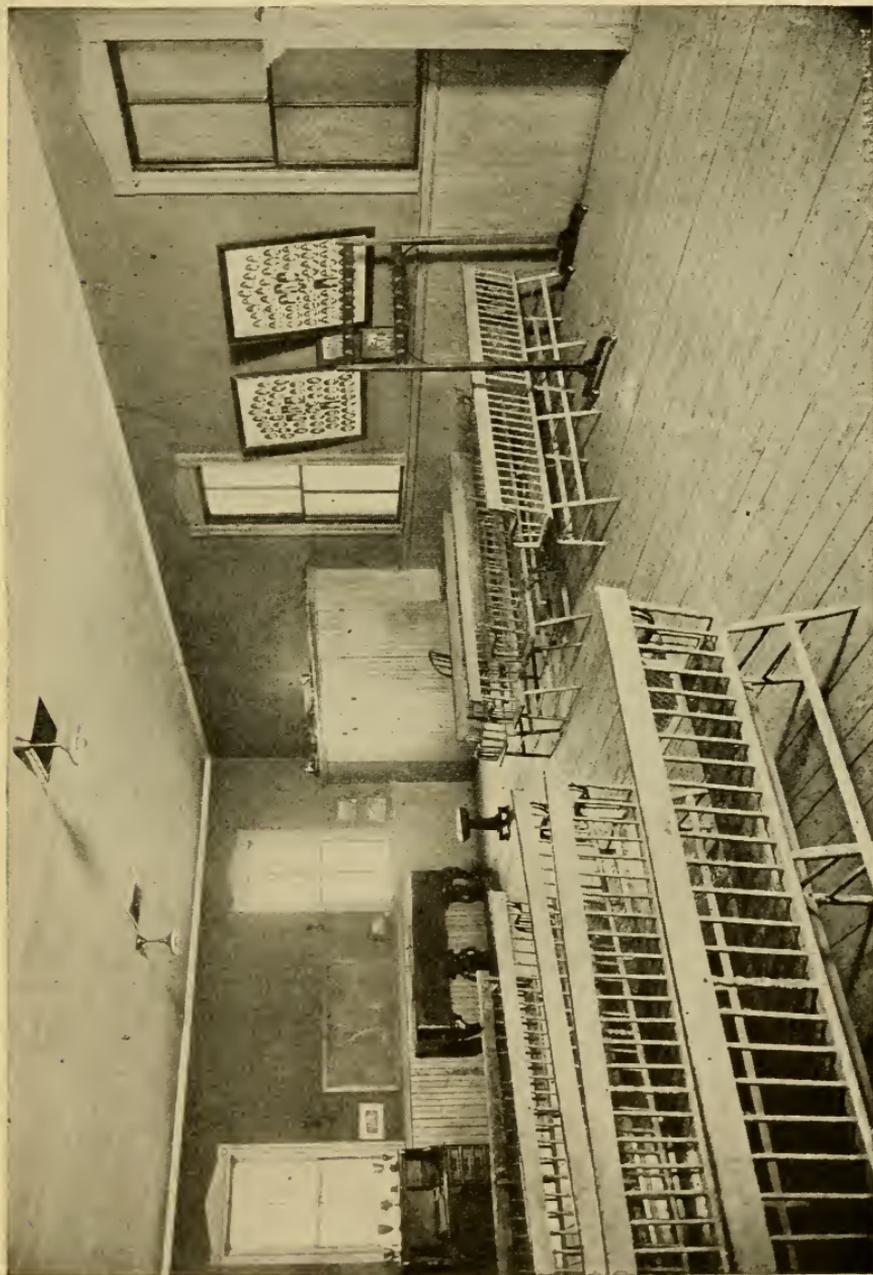
ILLUSTRATION 66. CHOIR ROOM IN THE TEMPORARY PART OF ST. PAUL'S EPISCOPAL CHURCH. ROOM IS LARGE ENOUGH BUT EQUIPMENT IS VERY POOR, AND NO ATTEMPT TO MAKE ROOM ATTRACTIVE

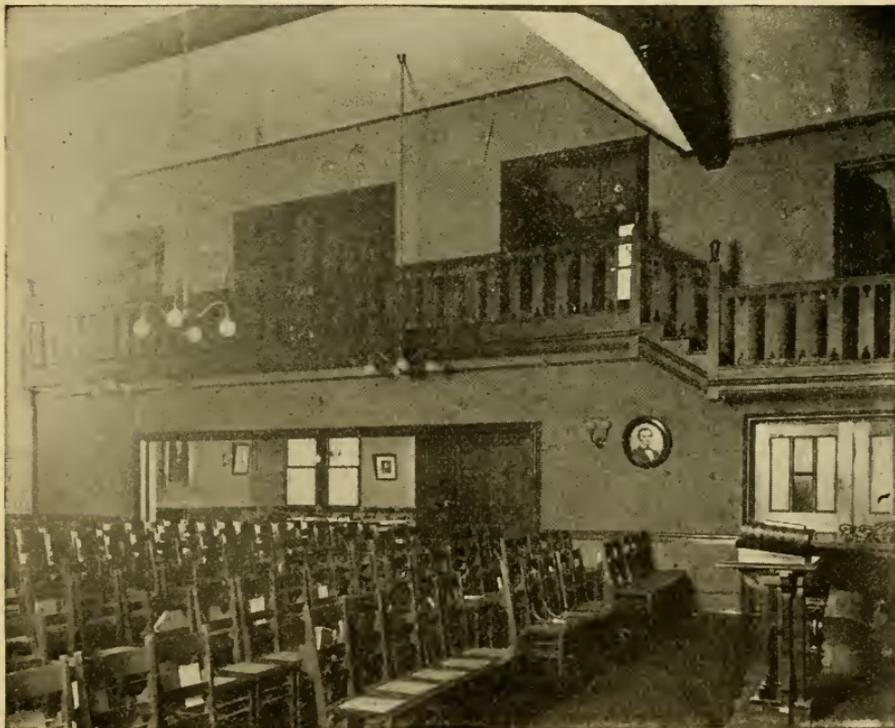
ILLUSTRATION 69. SUNDAY SCHOOL ASSEMBLY ROOM OF THE FIRST PARISH IN MALDEN, UNIVERSALIST. A WELL FURNISHED, IMPROPERLY LIGHTED ROOM, SHOWING BALCONY CONNECTION TO INADEQUATE CLASS ROOMS

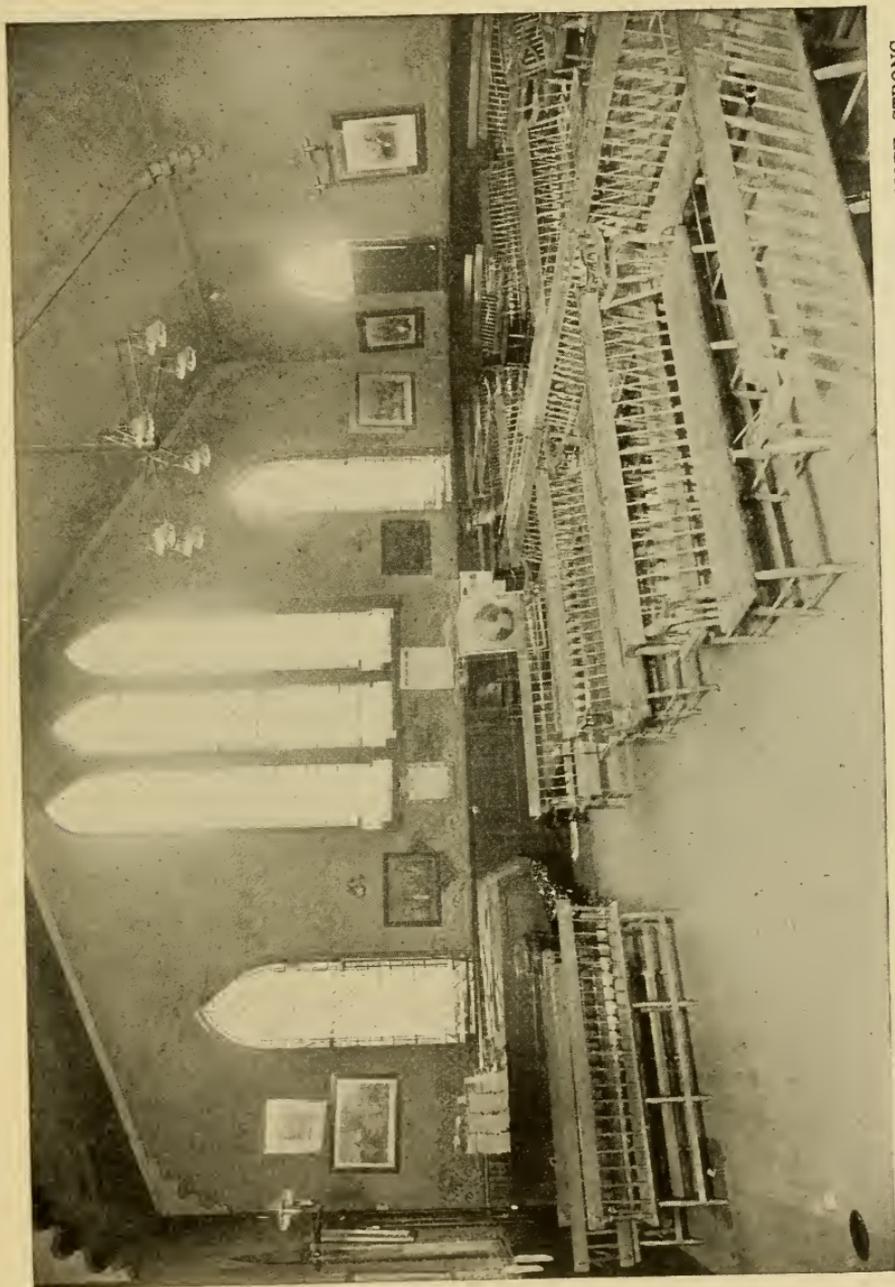
ILLUSTRATION 71. SUNDAY SCHOOL ASSEMBLY ROOM OF MAPLEWOOD BAPTIST CHURCH. NOTE STRONG LIGHT TO BE FACED, POOR ARTIFICIAL LIGHTING, AND BENCHES ARRANGED FOR SEATING A DOZEN OR MORE CLASSES IN THE SAME ROOM

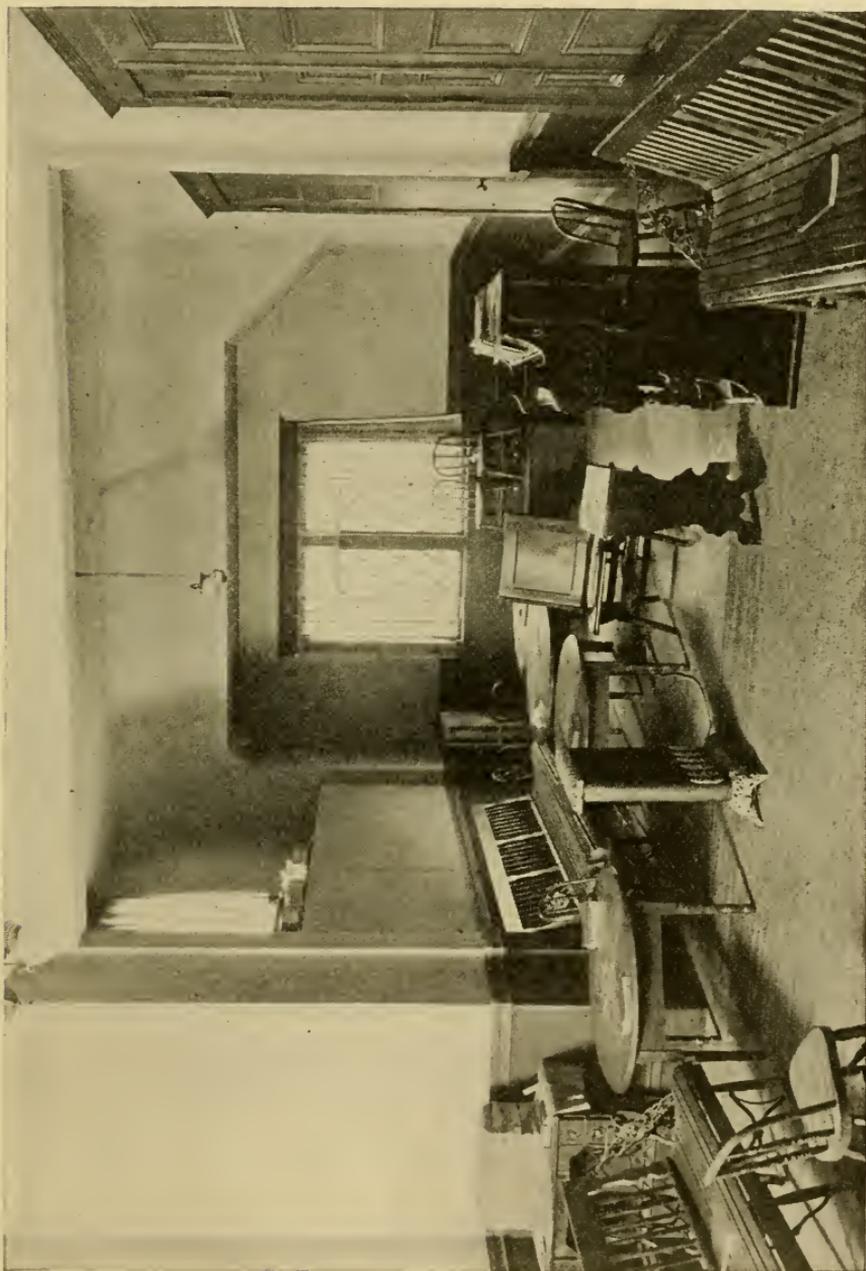
ILLUSTRATION 75. PRIMARY CLASS ROOM, FALCONER METHODIST CHURCH. IRREGULAR AND INADEQUATE FURNITURE, INCONVENIENT ARRANGEMENT, GAS HEATER, AND GAS LAMPS

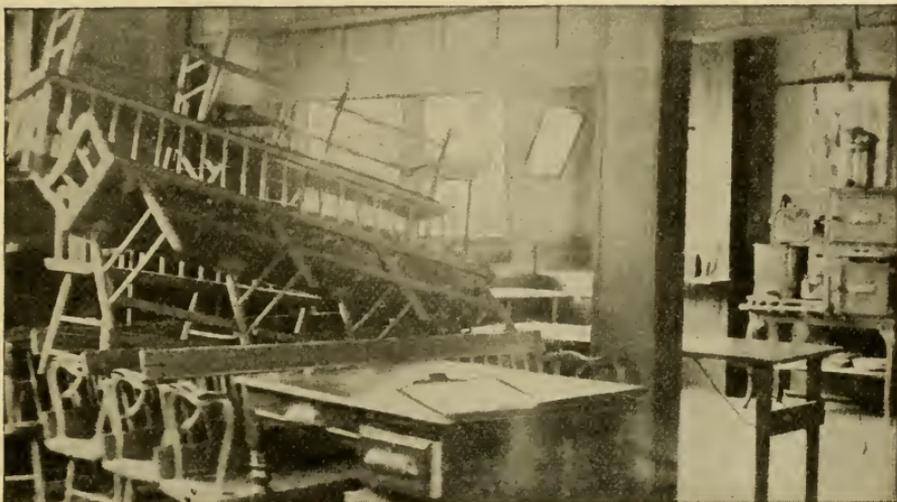
ILLUSTRATION 79. KITCHEN AND CLASS ROOM OF MAPLEWOOD BAPTIST CHURCH USED AS A STORE ROOM BECAUSE OF FAILURE TO PROVIDE SUCH SPACE IN ORIGINAL PLANS

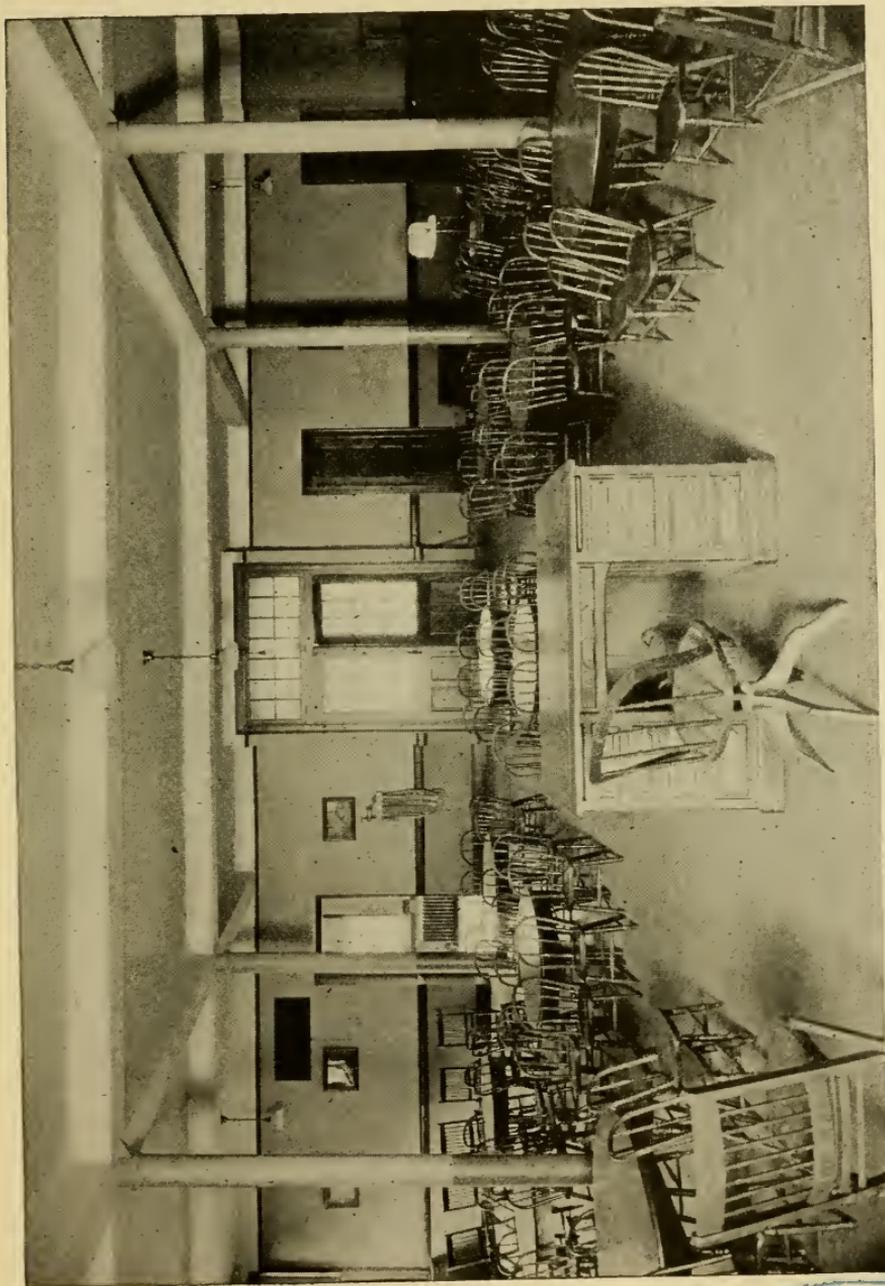
ILLUSTRATION 80. CLASS ROOM, FIRST BAPTIST CHURCH. WELL EQUIPPED, ATTRACTIVE CLASS ROOM, BUT WITH INADEQUATE NATURAL LIGHT DUE TO BLANK WALL ON ONE SIDE OF BUILDING

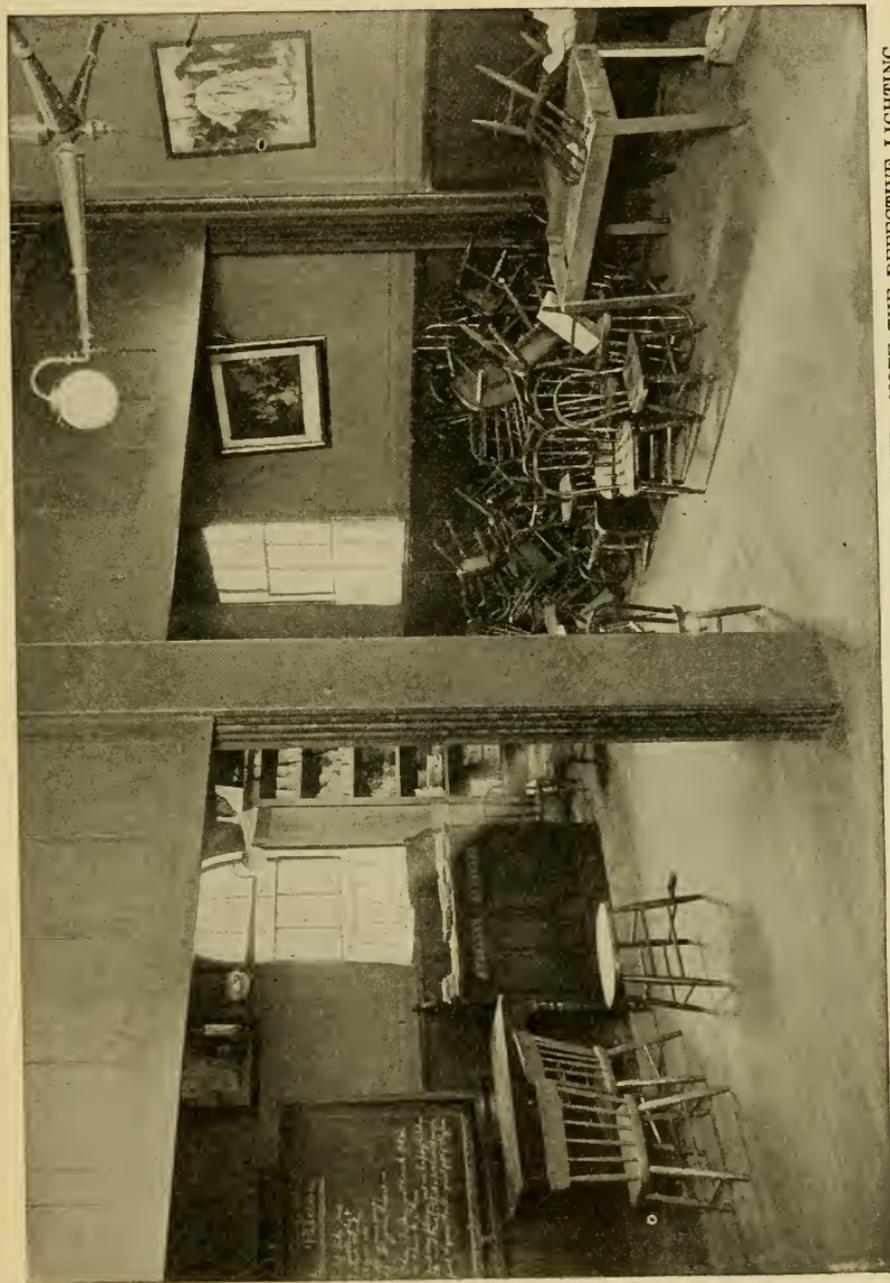
ILLUSTRATION 81. CLASS ROOMS IN THE MAPLEWOOD BAPTIST CHURCH. NOTE THE DEFECTIVE LIGHTING, THE POOR EQUIPMENT AND THE MAKESHIFT SAND BOX. TEACHING BECOMES DIFFICULT UNDER THESE CONDITIONS

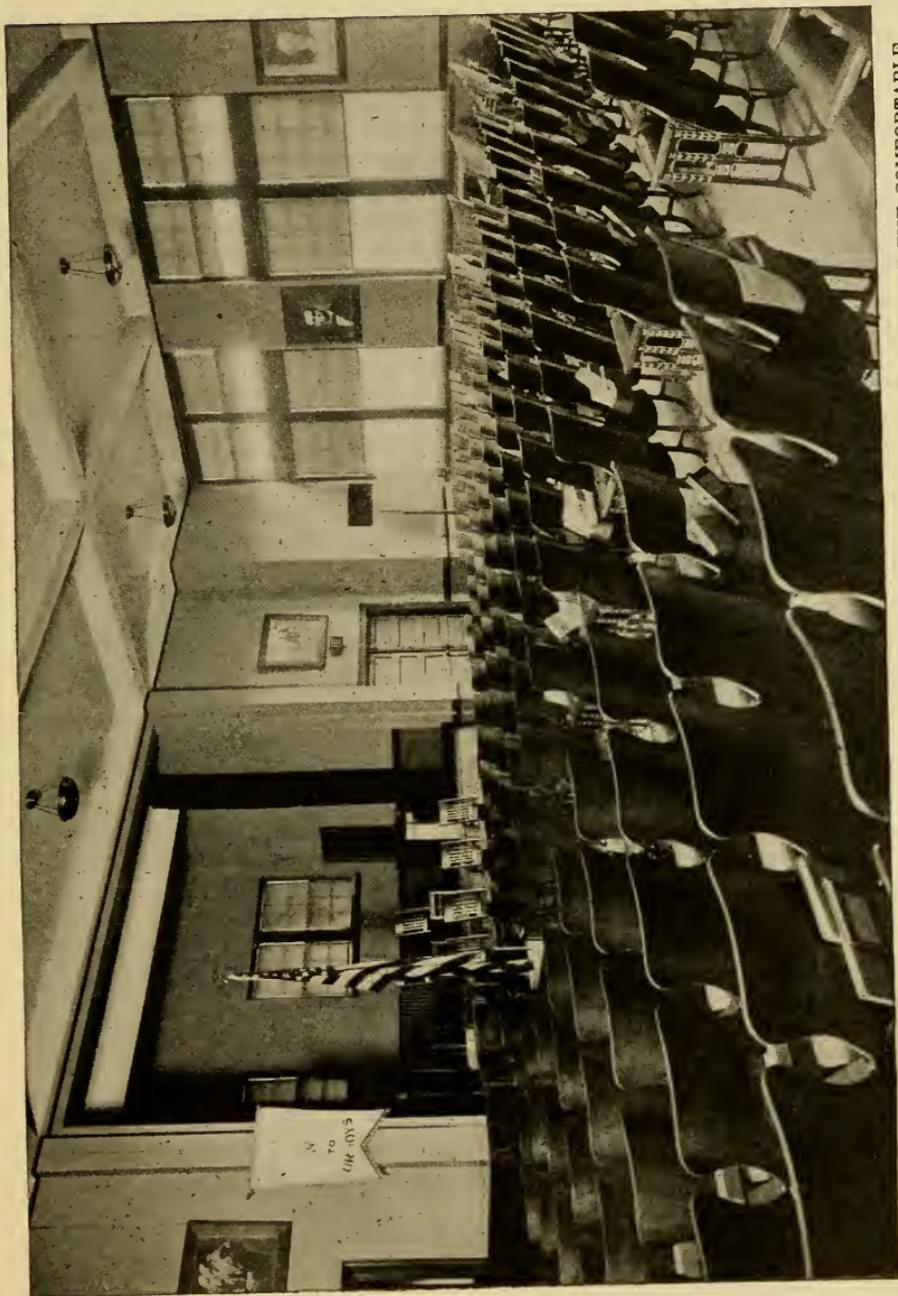
ILLUSTRATION 82. THE ADULT ASSEMBLY OF THE FIRST BAPTIST PARISH HOUSE. NOTE THE COMFORTABLE SEATS, THE WELL SELECTED PICTURES AND THE INDIRECT ARTIFICIAL LIGHTING. UNFORTUNATELY, NATURAL LIGHT COMES FROM THE RIGHT ONLY

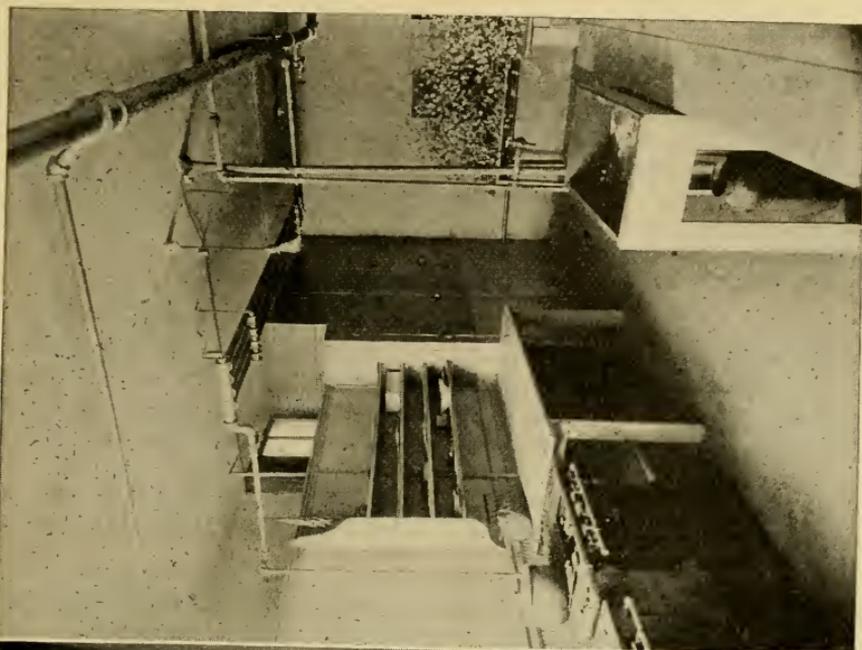
ILLUSTRATION 85. THE SMALL, INADEQUATE KITCHEN OF THE FAULKNER METHODIST CHURCH

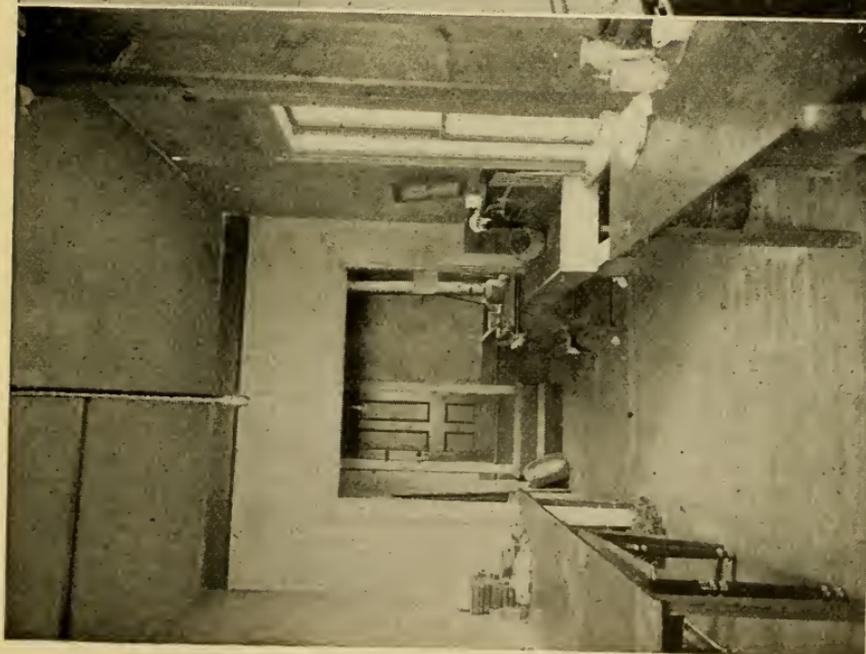
ILLUSTRATION 84. THE POORLY EQUIPPED KITCHEN OF THE LINDEN CONGREGATIONAL CHURCH
